SYNTHETIC STUCCO WATER INTRUSION REPORT

Date: January 9, 2007

Stucco Water Intrusion Report

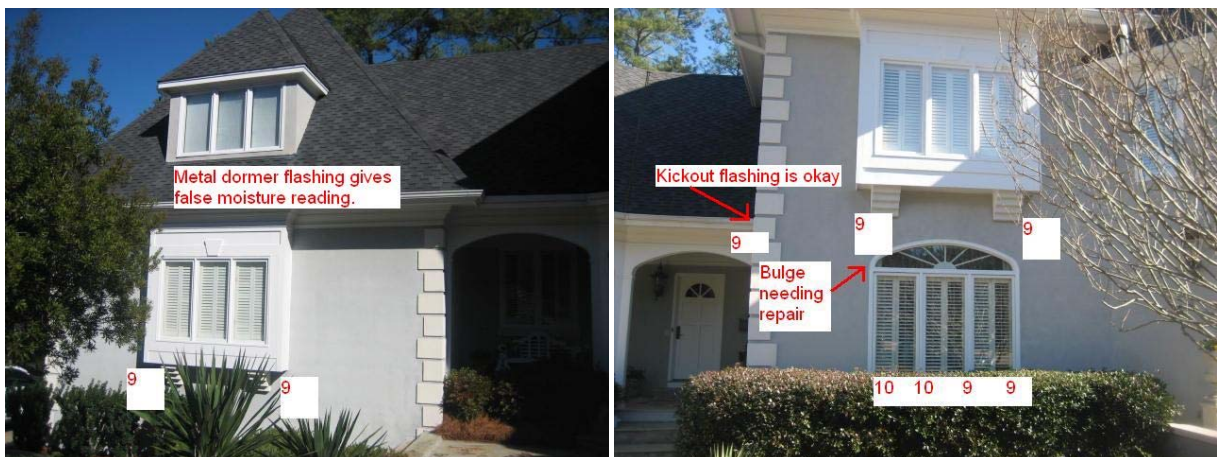
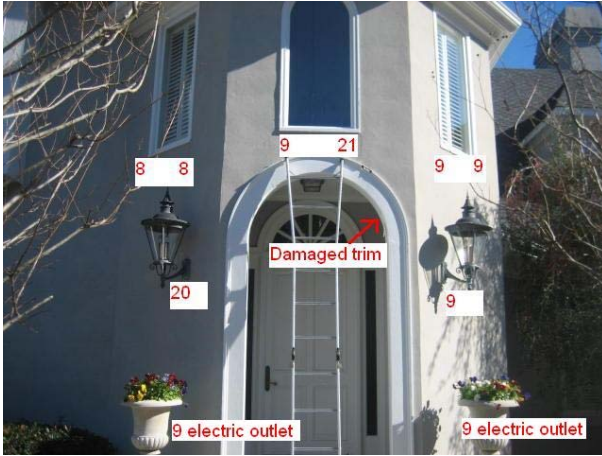
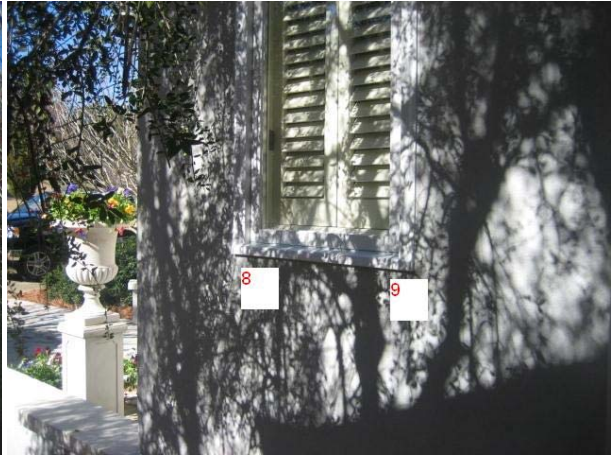
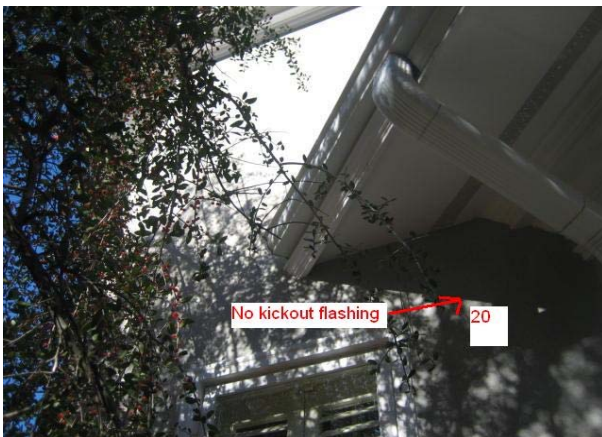
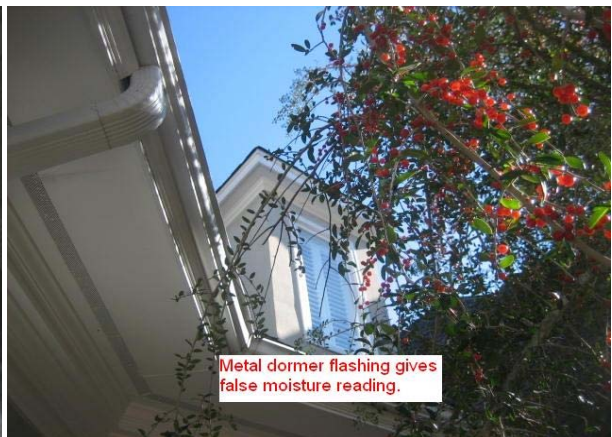
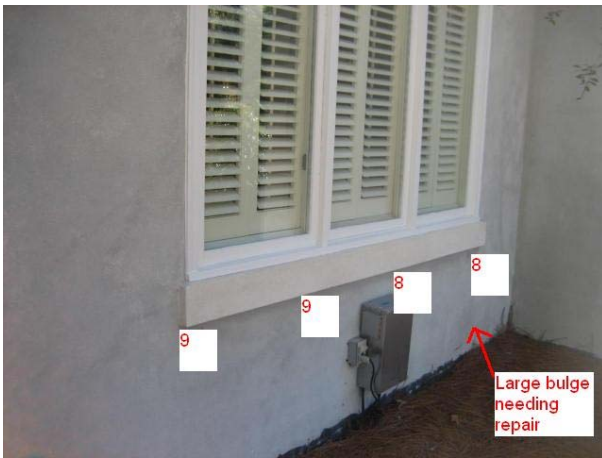
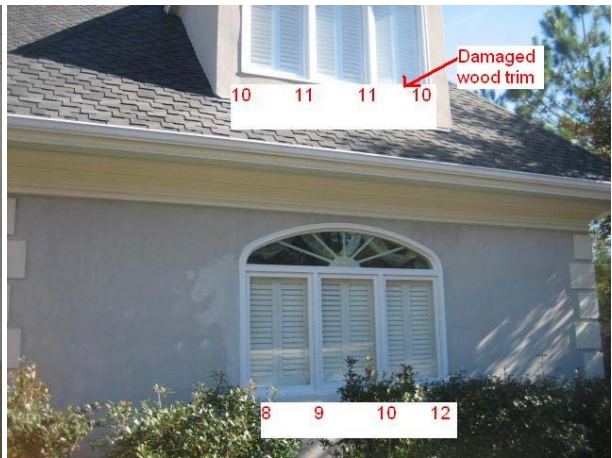
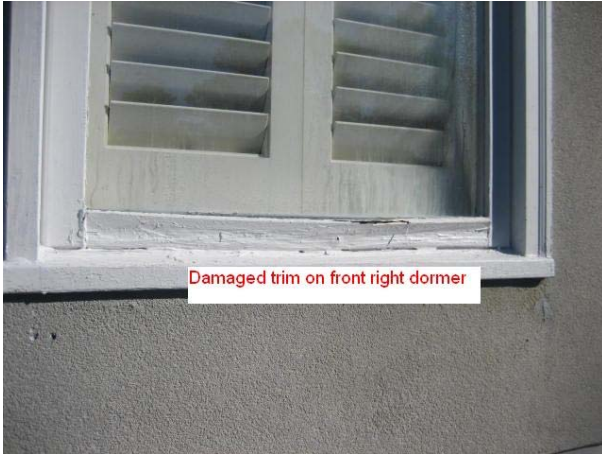
3. The exterior of the home is covered with synthetic stucco applied over an exterior Polystyrene substrate. This system is referred to as EIF's or Exterior Insulation Finish.
4. The bases of the stucco penetrations on the front of the house have the following moisture contents.

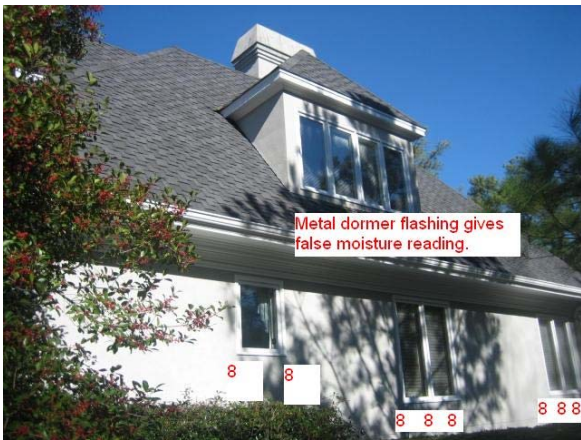
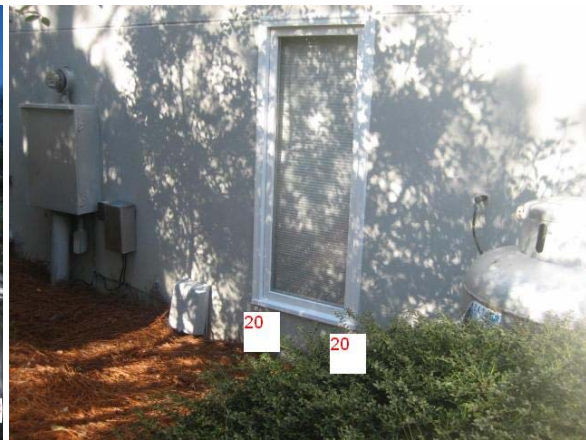
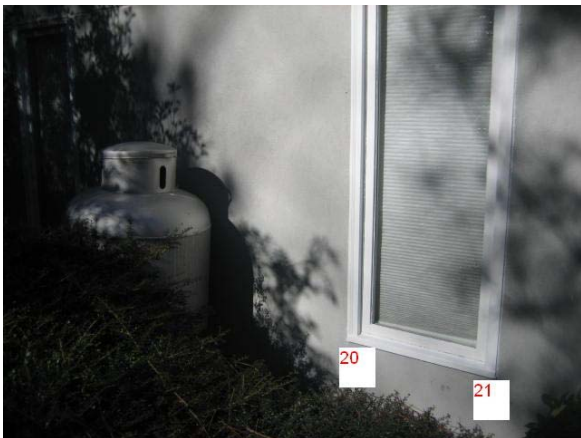
5. The bases of the stucco penetrations on the right side of the house have the following moisture contents.

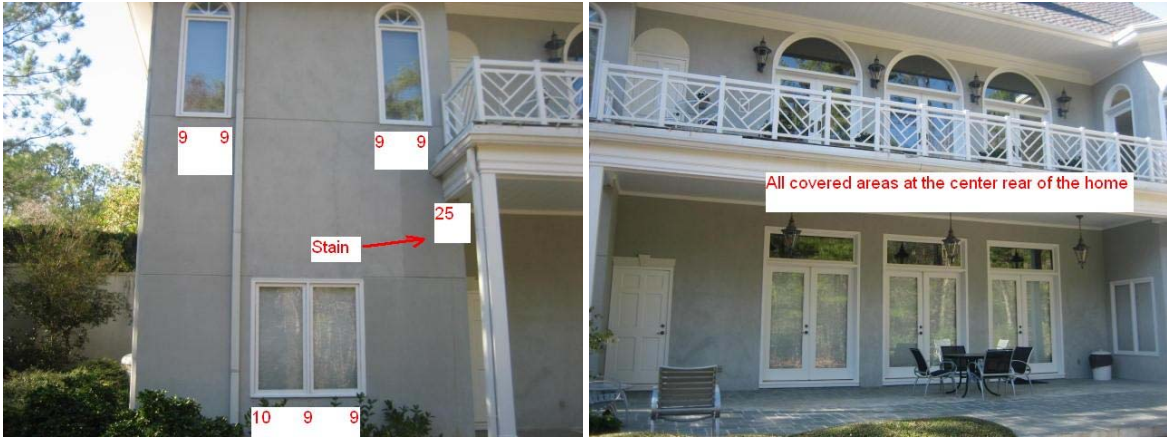
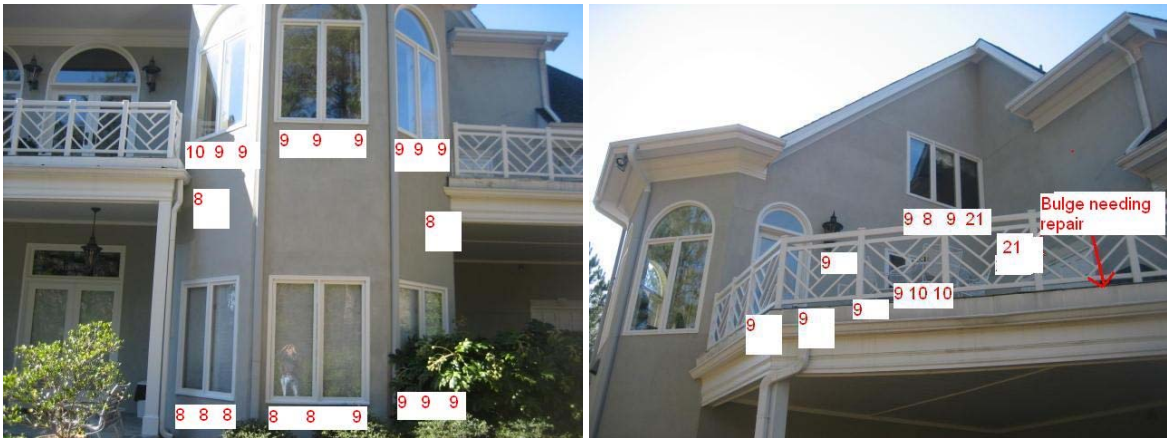
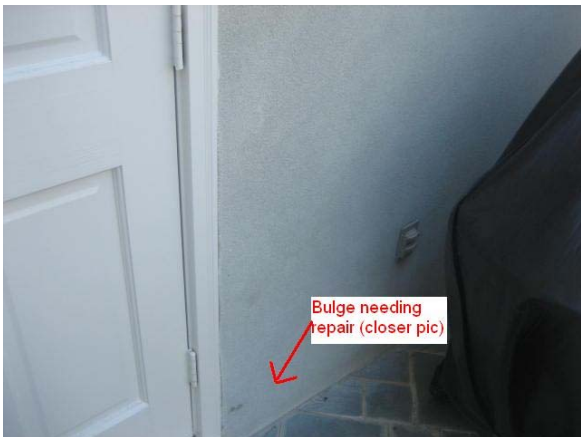
6. The bases of the stucco penetrations on the rear of the house have the following moisture contents.

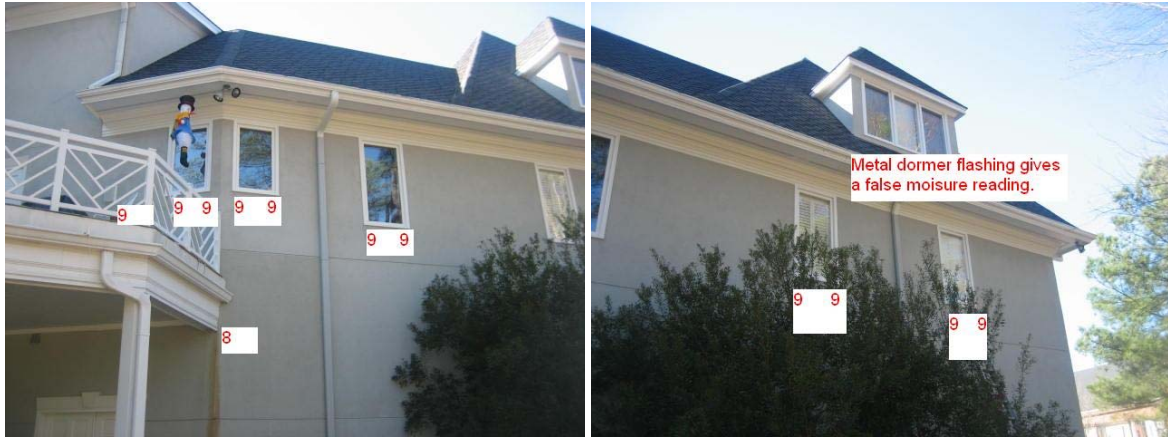
7. The bases of the stucco penetrations on the left side of the house have the following moisture contents.

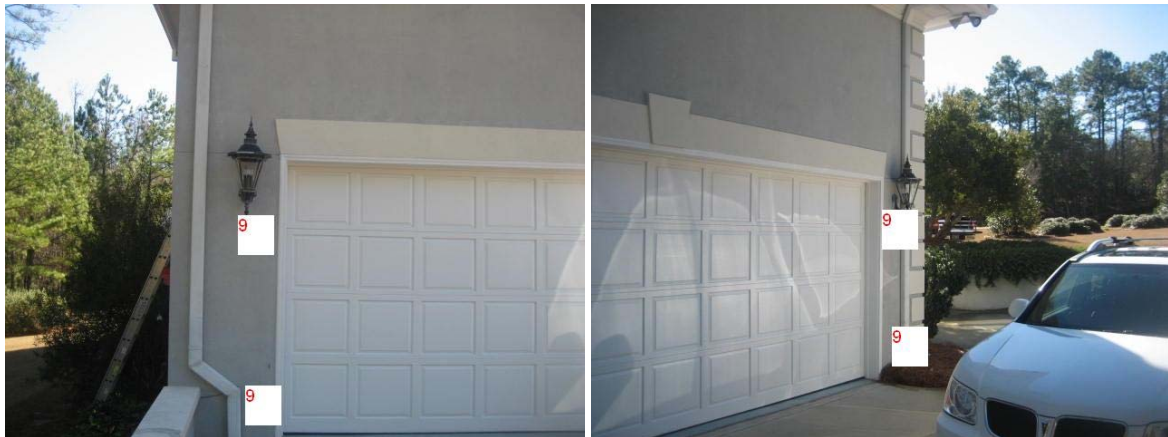
8. The bases of the stucco penetrations on the garage have the following moisture contents.
