WATER PENETRATION INSPECTION REPORT

Date: January 8, 2010

Water penetration inspection

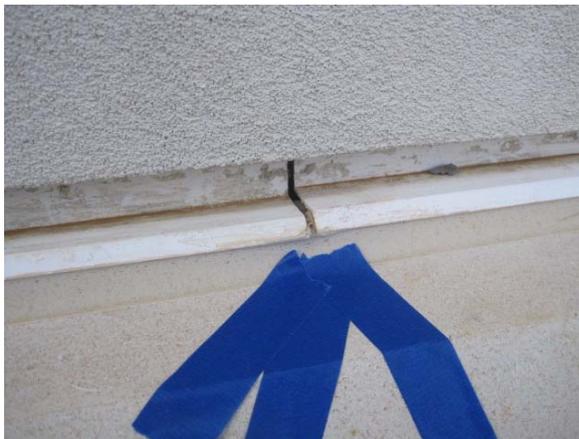
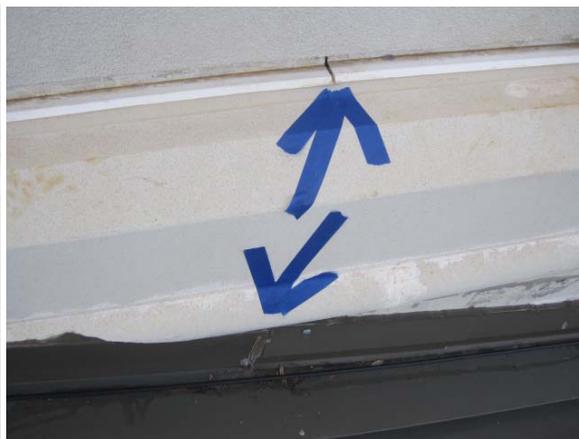
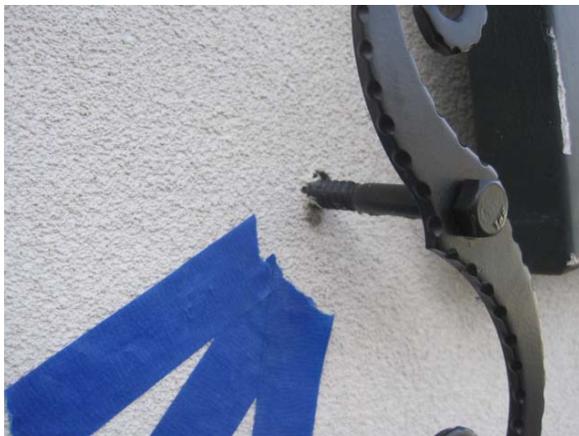
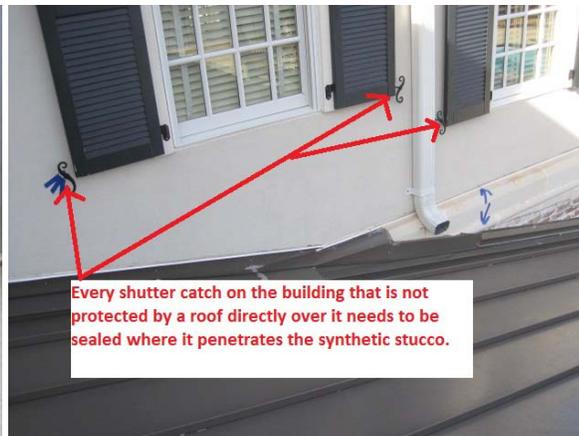
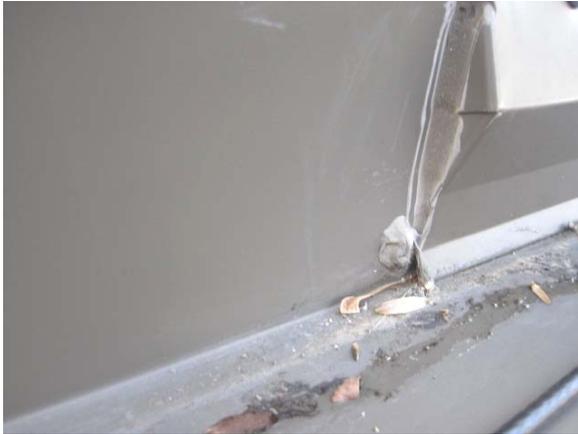
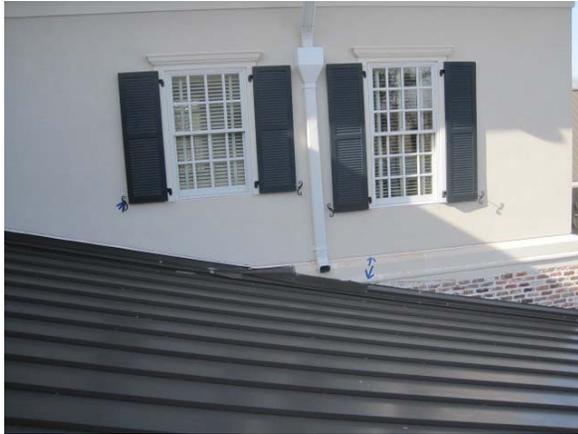
1. The step gable closest to the front of the building (1) has leaks at its caulking, flashing, and stucco penetrations. There is also a gap where drip edge above the masonry band is not caulked.

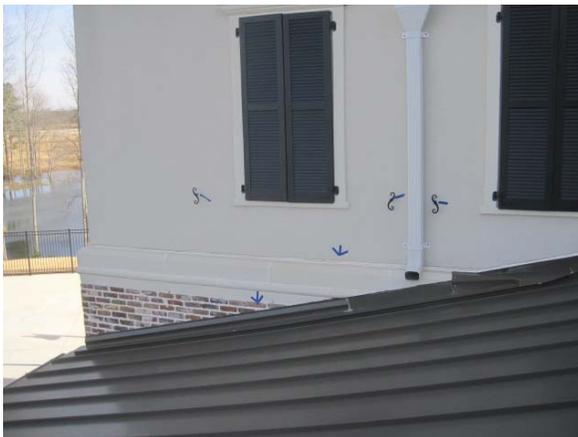
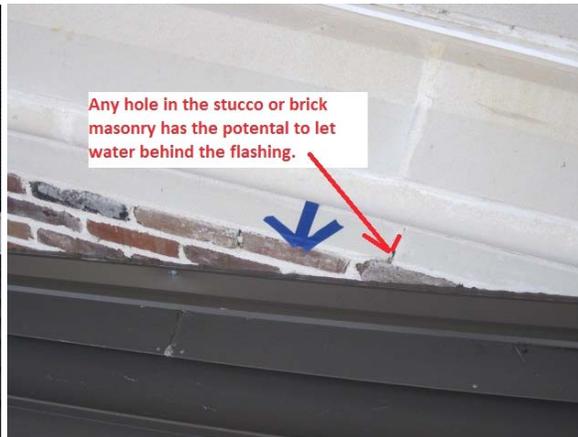
2. The corresponding step gable (2) at the left side near the rear of the building has similar problems.

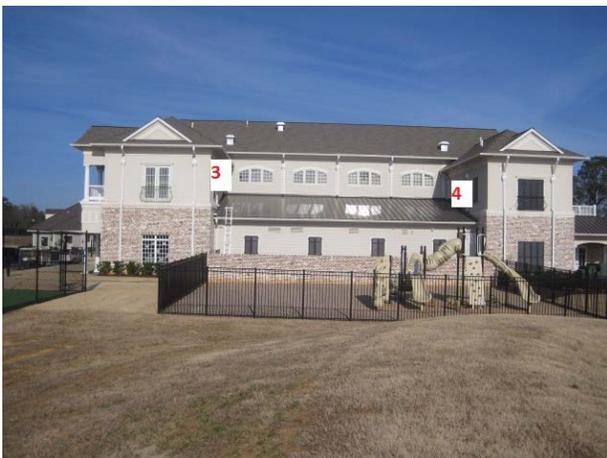
Step gables 3 & 4 at the right side of the building.

3. Gables 3 & 4 on the right side of the have the same problems as seen at the two left side gables.

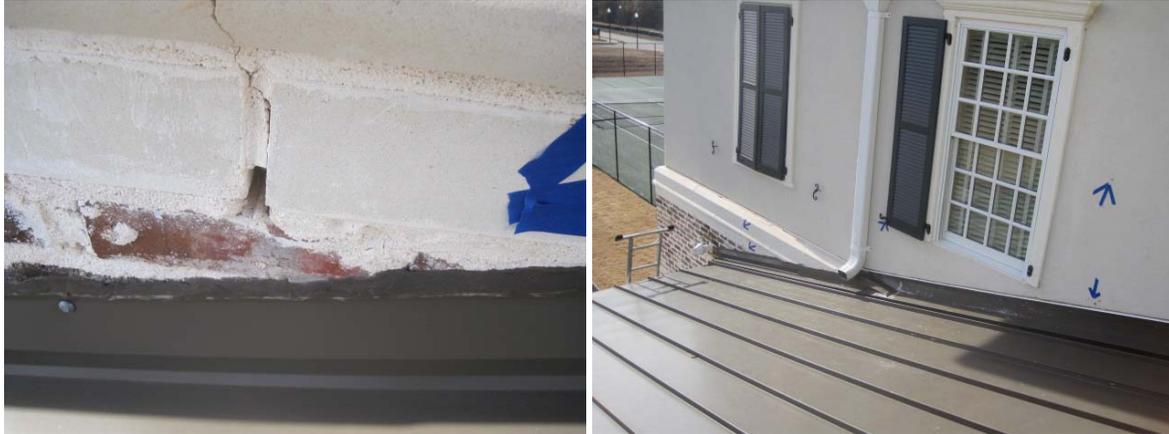
4. Gable 3 needs all its shutter bracket penetrations sealed. Holes from a missing shutter need sealed. Weep holes in the cement band that separates the stucco from the brick will allow water behind the stucco. Gaps in caulking need to be filled.

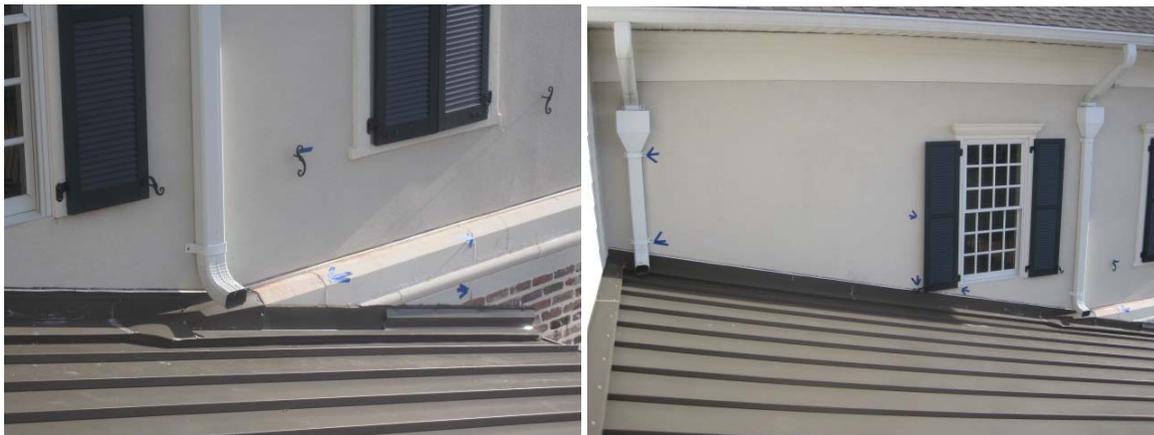
5. Gable 4 has the same problems as noted in gable 3 above (other than the missing shutter).

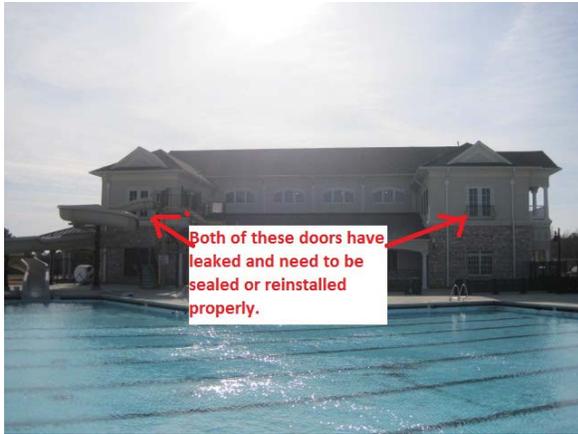
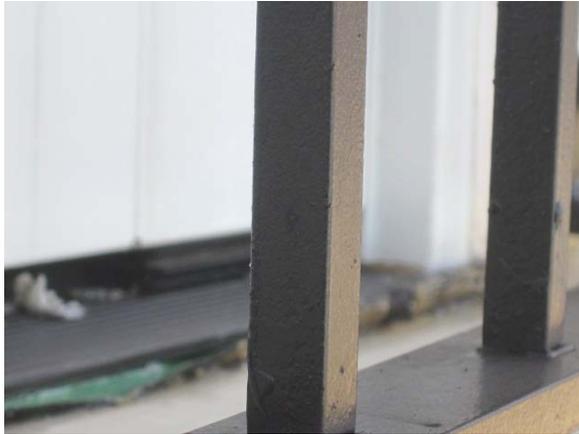
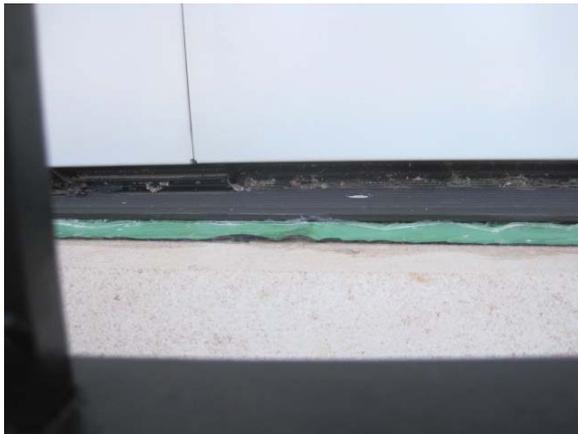
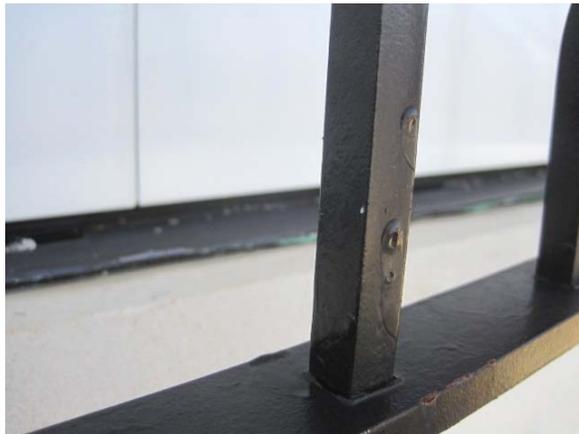
Four decorative doors with rails (2 on each side of the building) have gaps at their thresholds and can leak.

6. These two decorative doors are at the left side of the building. They both need to be sealed or reinstalled properly.

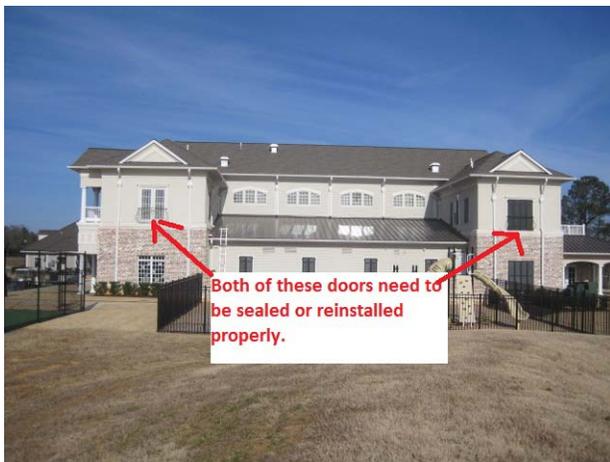
7. These two doors have the same problem at the right side of the building. They both need to be sealed or reinstalled properly.

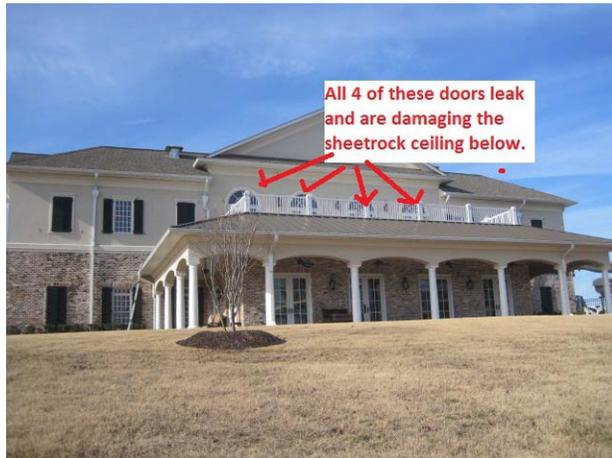
The rear balcony doors are causing the most penetration inside the building.

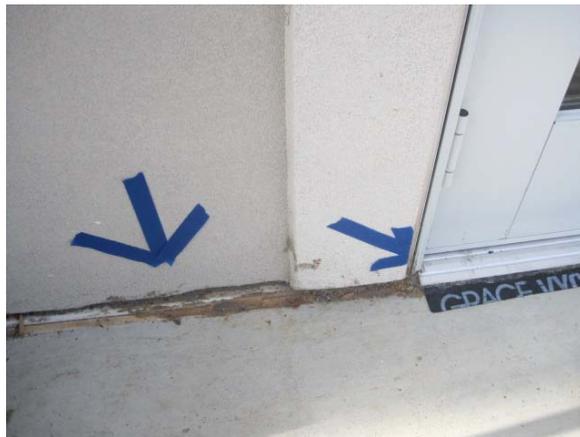
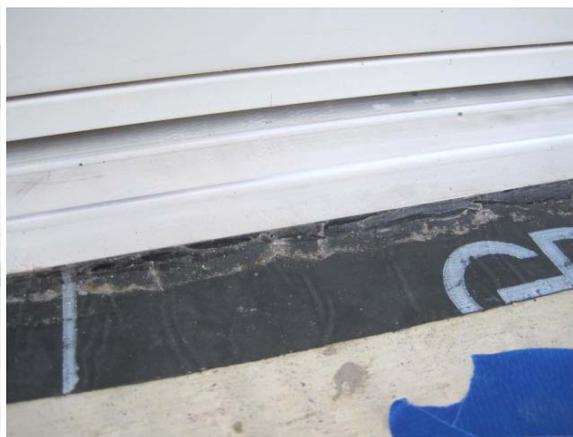
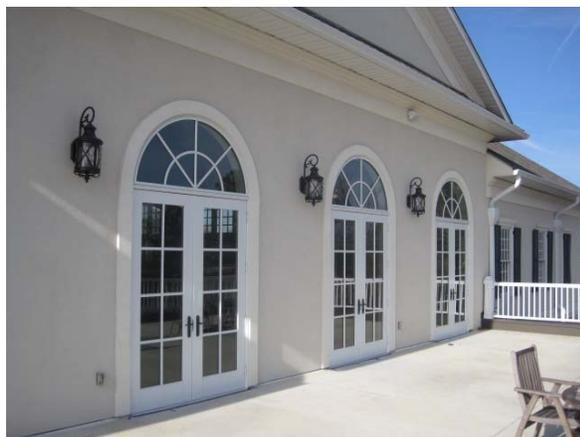
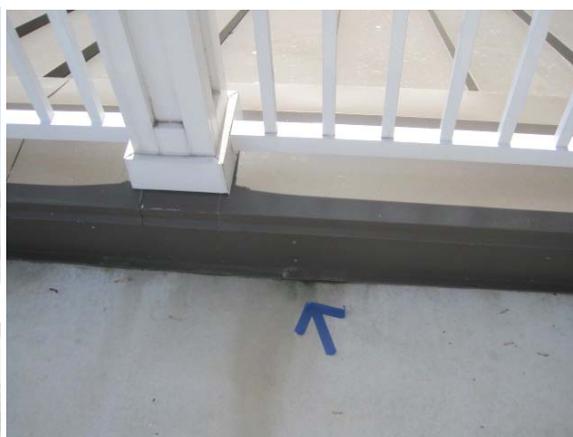
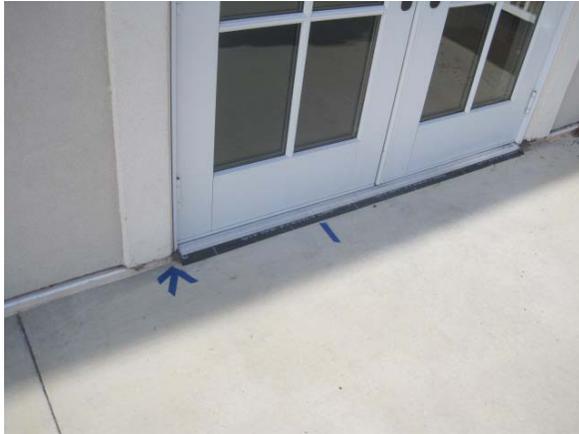
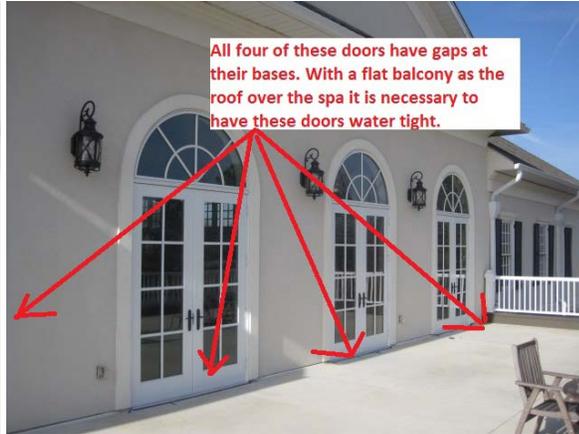
8. The following pictures are of the rear balcony door thresholds and the flat balcony itself. All 4 sets of doors need to be properly sealed or reinstalled correctly so they do not leak.

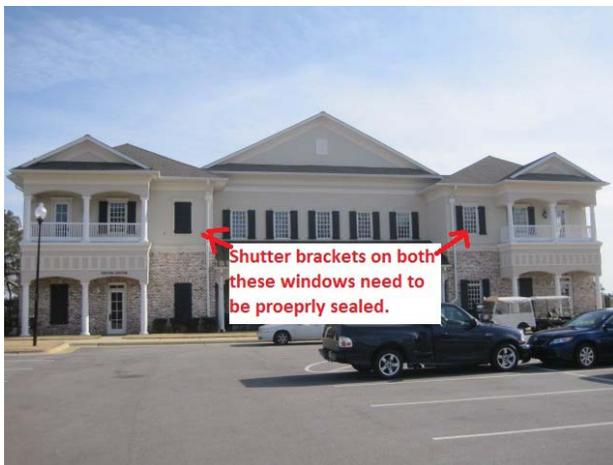
Front of the building

9. The front of the building has two windows that are exposed with shutter brackets penetrating the stucco that should be sealed.
